PUMPCOAT

CASE HISTORY 004 - REFURBISHMENT OF SALT WATER PUMP IMPELLERS, CASES & BASES

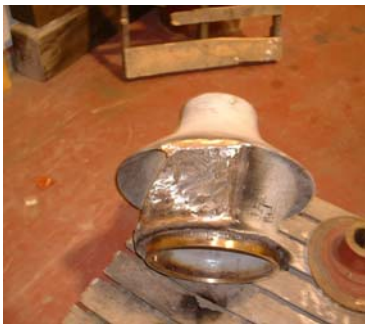
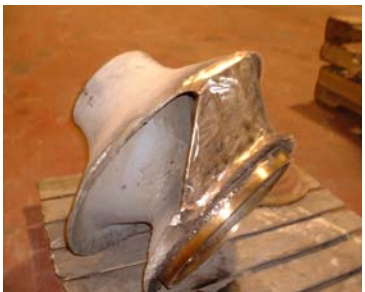
Power plant in New England needed to replace four bronze salt water impellers. New impellers were a 4 month lead time.

Pump impellers had run for 12 years with extensive vane wear.

Pumpcoat repair welded, epoxy coated and balanced the impellers.

Worn out casings were also refurbished by epoxy rebuild with Aluminum oxide filled epoxy.

Additional rebuild of the pump bases included welding, fabrication of new pump support feet and epoxy coating of the entire baseplate.
