PUMPCOAT

CASE HISTORY 007 - REPLACEMENT ASH AUGER COUPLINGS

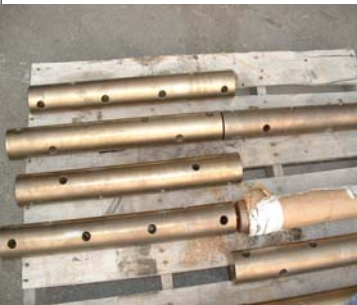
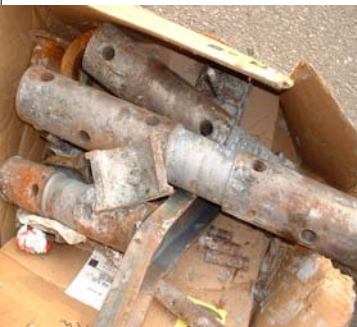
Trash burning Power plant in New England had excessive wear of screw auger couplings.

Original manufacturer's parts were made of case hardened steel, hardness depth was measured at .050 inches. Due to the abrasive nature of the ash handling system, parts were wearing out and needing replacement a few times a year.

Pumpcoat repairnet vendor manufactured A-2 steel replacement parts which were through hardened to 65 Rc.

Increased life is not yet determined as parts are yet to wear out. Parts have been in service for more than 5 years.
