PUMPCOAT

CASE HISTORY 011 - CHILLER CONDENSER COATING

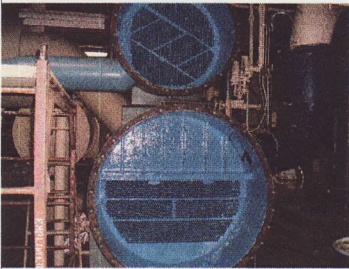
Building in Boston found excessive corrosion of condenser.

Previously uncoated tube sheet and water box were in need of epoxy coating.

Pumpcoat provided grit blast, dust collection and coating of tube sheets, waterboxes, division plates and heads.
