# PUMPCOAT

## THE RIGHT SOLUTION TO YOUR PUMP AND COATING PROBLEMS

### CASE HISTORY 027 - CONDENSER WATER BOX REPAIR

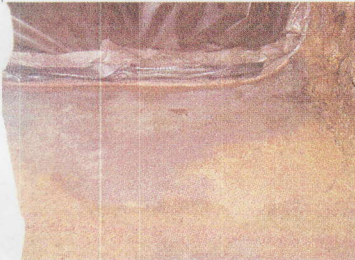
Customer had hole in condenser water box.

Pumpcoat coating technician repaired hole by grit blasting, applying paste grade epoxy to fill the corroded area, and then a top coat to seal and waterproof. Patch was reinforced with polyester cloth. Patch has been working for 5 years.

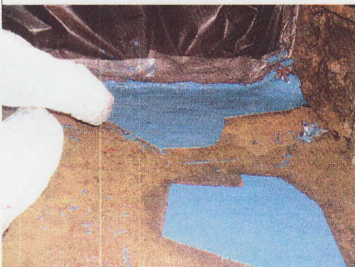
Corrosion weakened the metal and customer needle-gunned a hole in condenser water box.
