CASE HISTORY 031 - HEAT EXCHANGER DIVISION PLATE COATING

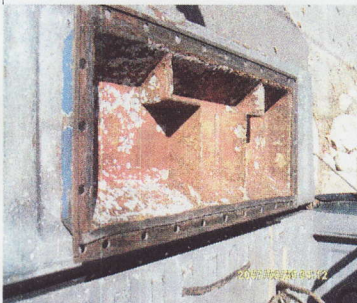
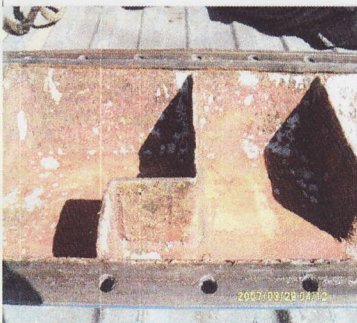
Division bars on heat exchanger cover were corroded.

Customer experiencing leakage where the division plate bars had corroded.

Pumpcoat grit blasted the cover and repair welded the division bars. Piece was then epoxy coated for corrosion resistance.
