CASE HISTORY 001 - SPECIAL SHAFT SLEEVE FOR HEAVY OIL PUMP AT POWER PLANT IN NEW ENGLAND

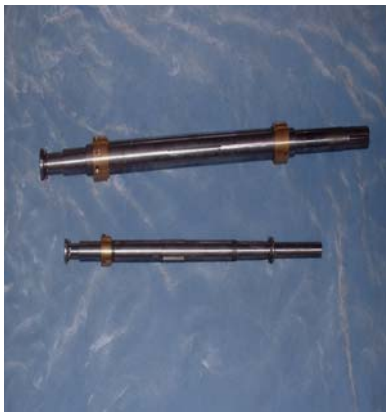
Power plant in New England needed to install mechanical seal for a heavy oil pump, but set screws wouldn't fit on the pump shaft sleeve. The set screws landed on a shaft sleeve shoulder.

Mechanical seal set screws were not fitting on the pump shafts sleeve. The pump shaft sleeve was too short. It needed to be longer.

Pumpcoat designed and our vendor manufactured a special shaft sleeve customized for the pump. The customer was then able to install the mechanical seal.
