PUMPCOAT

CASE HISTORY 009 - TRAVELING WATER SCREEN REPAIR

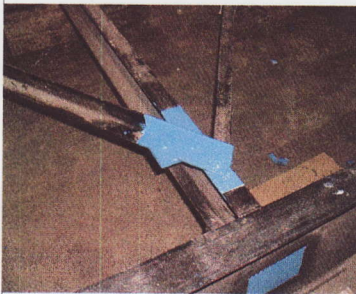
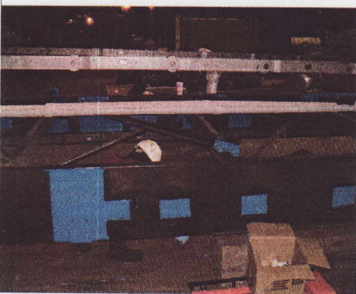
Traveling Water Screen frame rusts out.

Customer welds and strengthens new traveling water screen frame prior to installation. Heat from welding destroys factory coating.

Pumpcoat provides qualified coating people to identify coating repair areas, grind and prepare those areas and coat with two coats of ceramic epoxy.
