PUMPCOAT

CASE HISTORY 022 - HIGH FLOW PUMP

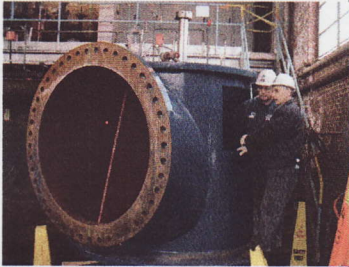
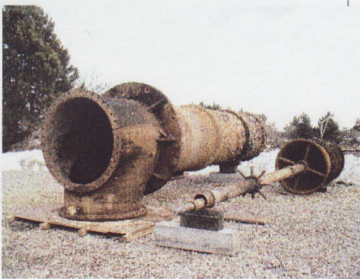
Customer needed replacement salt water pump.

Customer salt water pump was 40 years old.
Customer decided to order a new pump which would fit into existing pump location.

CPG worked with Ruhrpumpen to design a 316 SS pump with 2 % Nickel cast iron head which bolted in and duplicated existing pump hydraulics.

The new pump was designed so that the Nitronics 50 line shaft couplings were interchangeable with the customers existing pumps to reduce inventory.
