# PUMPCOAT

### CASE HISTORY 033 - EPOXY COATED & CUSTOM PUMP BASES

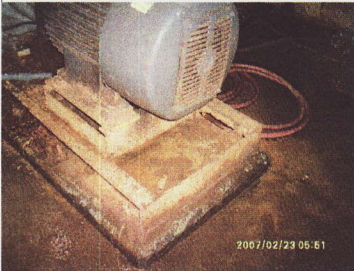
Trash burning power plant had excessive corrosion on several pump bases.

Customer had fish pumps in salt water service. The pump bases had suffered corrosion & oxidation.

Pumpcoat mobilized to customers site to blast, repair damage, and epoxy coat the pump bases. This repaired & prevented further damage and the coating offered extra wear resistance for the future. In cases of extreme damage or an existing base, Pumpcoat also has the capability of custom manufacturing pump bases to specifications.
