PUMPCOAT

CASE HISTORY 003 - ABRASIVE RESISTANT EPOXY USED TO INCREASE PARTS LIFE

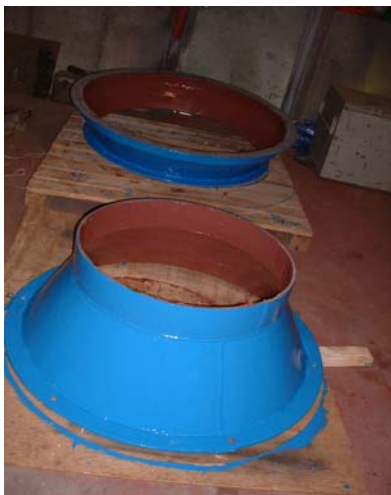
Power plant in New England needed to increase coal pulverizer parts wear resistance.

Plant maintenance people replaced classifier cones on a regular basis. The plant desired longer life with decreased maintenance man hours and decreased parts cost.

Pumpcoat coated new classifier cones with thick film abrasive resistant epoxy. Worn out parts were also refurbished by welding patches and rebuild with Aluminum oxide filled epoxy.
