# PUMPCOAT

### CASE HISTORY 009 - TRAVELING WATER SCREEN REPAIR

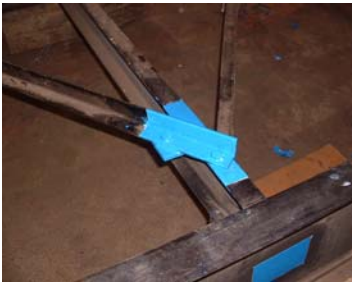
Traveling Water Screen frame rusts out.

Customer welds and strengthens new traveling water screen frame prior to installation. Heat from welding destroys factory coating.

Pumpcoat provides qualified coating people to identify coating repair areas, grind and prepare those areas and coat with two coats of ceramic epoxy
